STEERS MILL DAM

DINWIDDIE COUNTY, VIRGINIA

# PHASE I INSPECTION REPORT

## NATIONAL DAM SAFETY PROGRAM

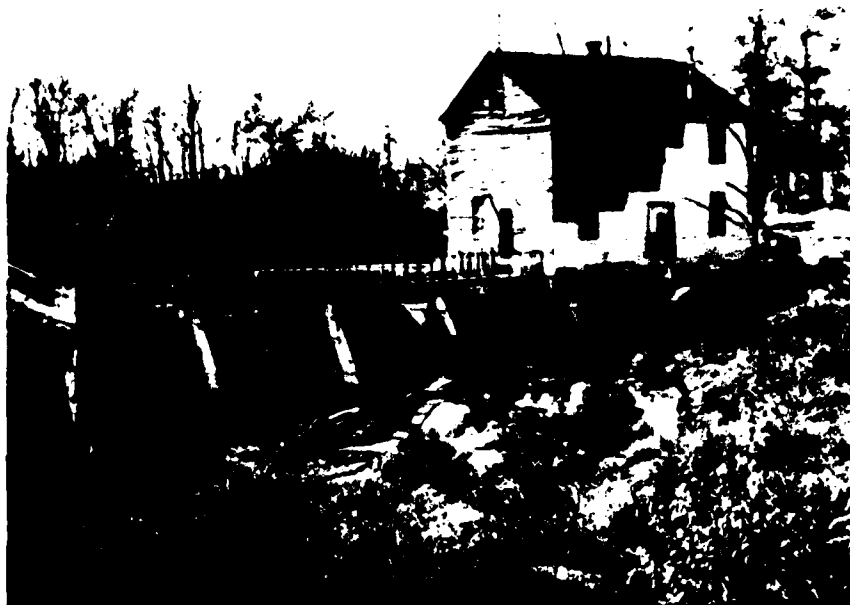
Photograph No. 1 - Overflow Section at Left  
End of Dam, Catwalk, Turbine House and Mill (Arrow)

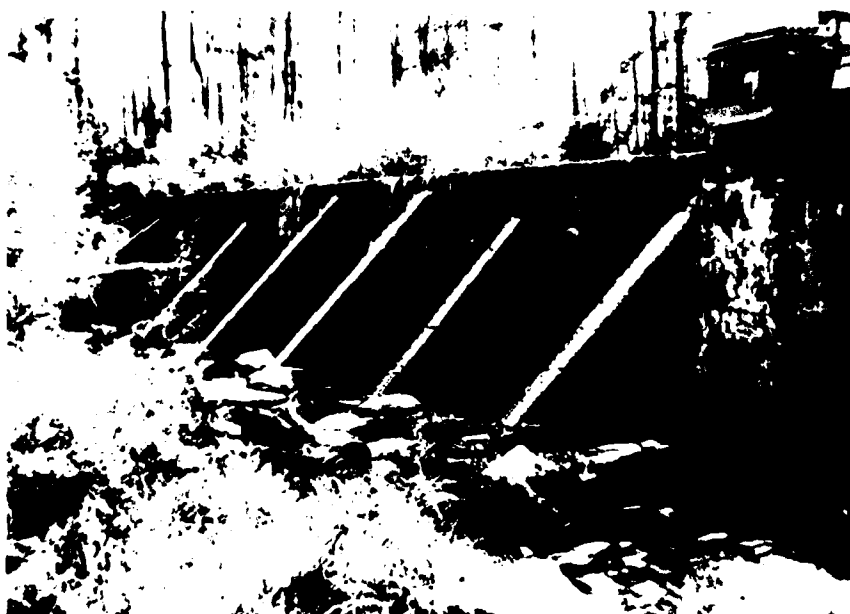
Photograph No. 2 - Overflow Section, Right End of Dam

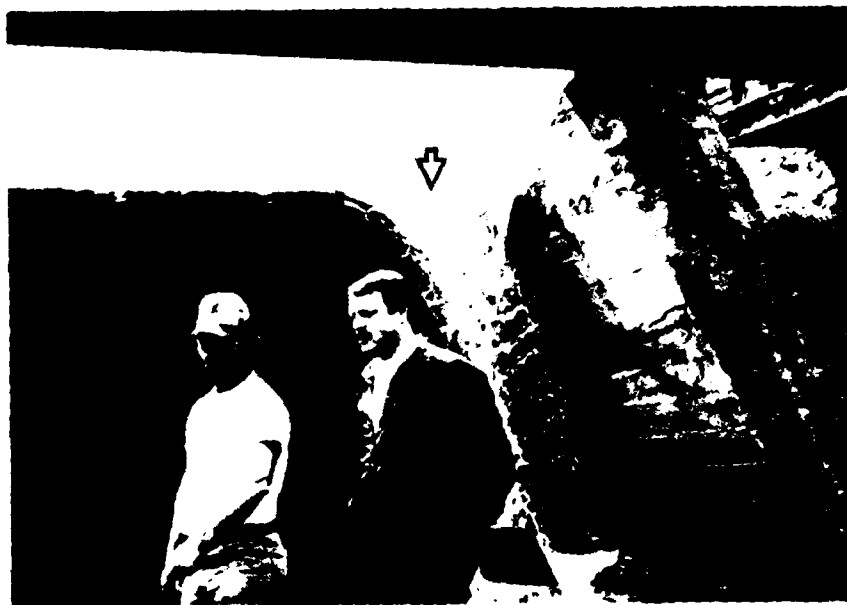
The dam crest indicated signs of spalling concrete in several areas. Damage was also noted in the overflow section of Counterfort No. 11, (see Photograph No. 4, Appendix II). Some weathering and spalling was also observed on the counterforts and face of the dam. Severe cracking was observed on Counterfort No. 3, while less obvious cracking was noted at several other locations.

Photograph No. 4 - Damaged Area of Overflow Section  
(Arrow)

7.3.1 Spalling concrete and scattered cracking on the dam should be repaired including the damaged overflow section at Counterfort No. 11.

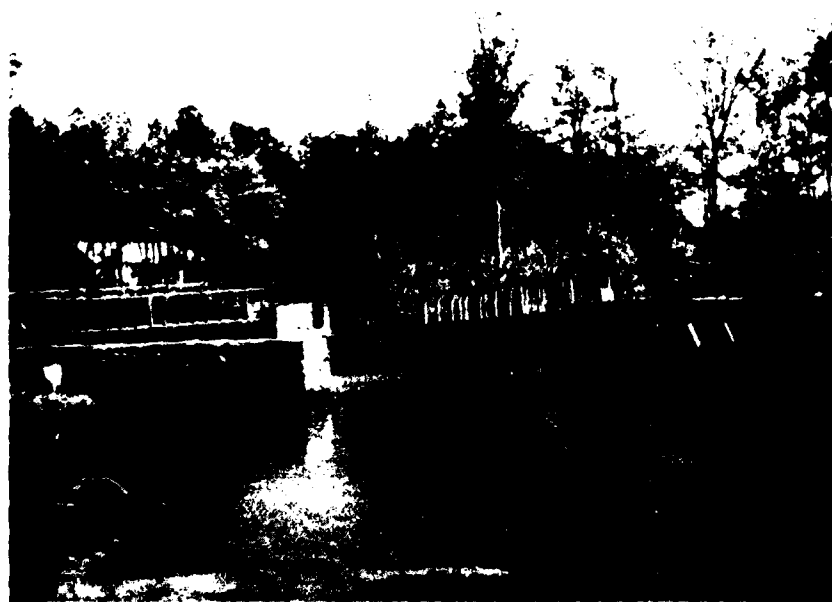
Photograph No. 6 - Turbine Intake Structure (Arrow)

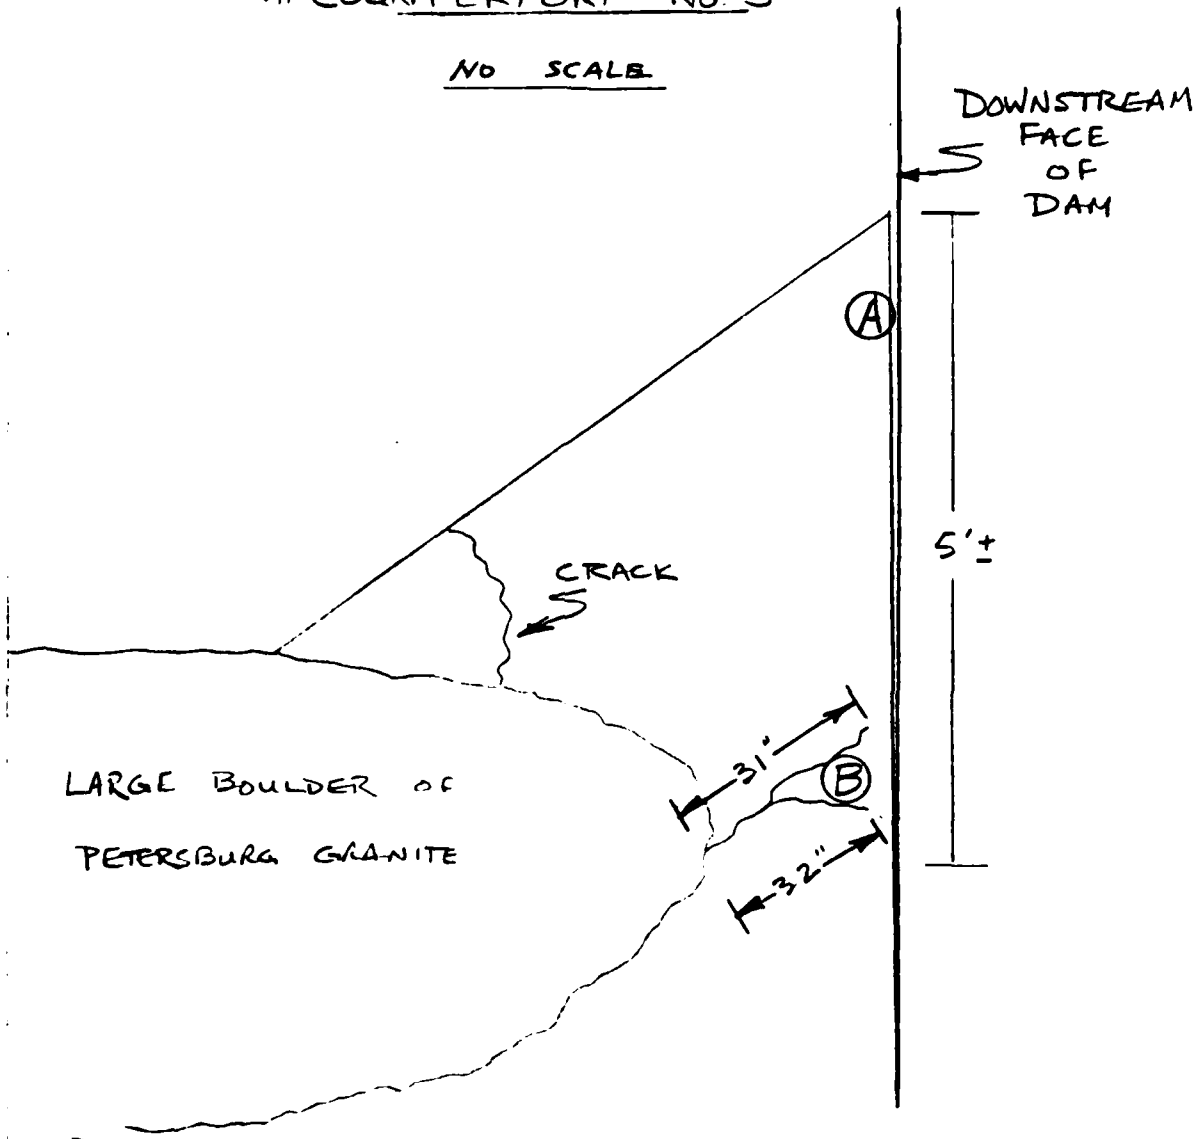
STRUCTURAL CRACKING  
AT COUNTERFORT NO. 3

- Ⓐ UPPER 5 FT OF COUNTERFORT SEPARATED FROM DAM 1 - 3 INCHES ±
- Ⓑ STUCK RULER INTO THE 31 INCH CRACK, TO DEPTH OF 8 INCHES

studies and design work. The structural cracks observed in the counterforts (particularly No. 3) should be examined during this study and repairs made as determined necessary.
